# BRIANT PARK DAM

(NJ 00784)

## PHASE 1 INSPECTION REPORT. NATIONAL DAM SAFETY PROGRAM

PHASE I REPORT  
NATIONAL DAM INSPECTION PROGRAM

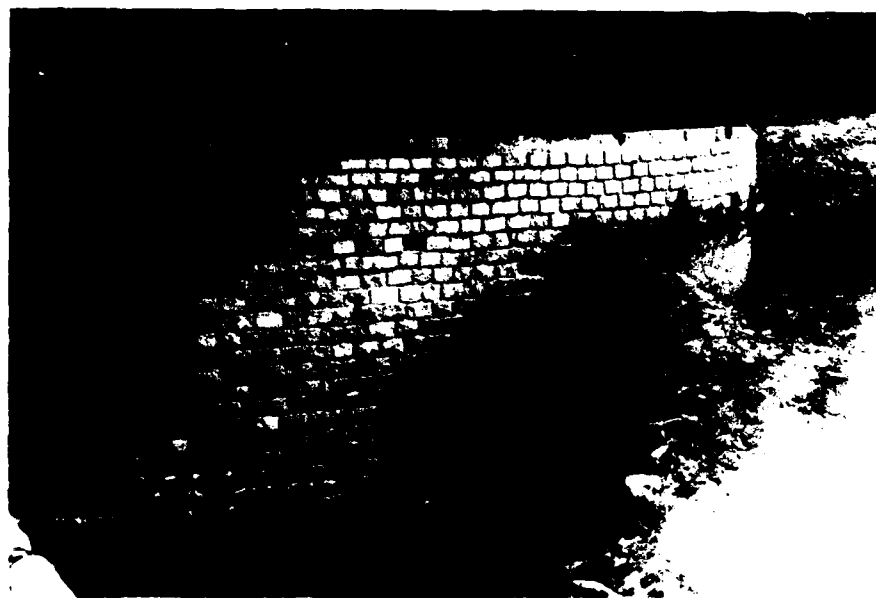
The concrete arch spillway and retaining walls contain rubble-stone veneer on all exposed faces. With the exception of minor cracking of the mortar between the facing stone, the spillway appears to be in excellent condition despite its age. Similarly, the retaining walls and culvert entrance appear in good condition, although a few surface blocks are missing from the right retaining wall, where cracking and a slight bulge was noted in the top seven courses of block. Although the weep holes were dry at the time of the inspection, water was emanating from the 36-inch drain, which, since the valve was reputedly closed at the time, suggests that either the valve or the seat has deteriorated and requires repair. Moreover, the cast iron cover plates on the manhole containing the gate valve for the drain are welded shut, making access to the gate valve impossible in the event of an emergency dewatering situation. The downstream top wall of the culvert is completely undermined, and the left end of the wall is cantilevered for a distance of approximately five feet. The wing-wall adjoining the left side of the culvert has collapsed into the downstream channel, and severe erosion behind the right wingwall threatens a similar fate for that structure. Very light debris was noted at the spillway crest.

VISUAL EXAMINATION OF	OBSERVATIONS	REMARKS OR RECOMMENDATIONS
CONCRETE WEIR	Covered with masonry veneer in good condition. Side retaining walls in fair condition. Some masonry blocks missing, and cracking of mortar noted. Slight bulge in veneer on right wall. Probably frost-action related.	Minor repointing necessary at spillway. Masonry veneer not necessary for structural integrity, although it prevents weathering of the concrete structure. Blocks should be replaced and cracks repointed.
APPROACH CHANNEL	N/A	
DISCHARGE CHANNEL	Some large stone downstream, moderately vegetated with steep, relatively high side slopes. Stone stilling basin clear and appears in good working condition.	3 inch dia. weep drains in the side walls were dry at the time of inspection.
BRIDGE AND PIERS	Roadway box culvert about 30 feet downstream from spillway. Culvert and spillway hydraulic capacity approximately equal.	Calcs. indicate dam is overtopped about time culvert becomes the control.

View of Spillway and Retaining Wall

(1) The spillway and sidewall masonry should be repaired and repointed.

(2) The bulge in the right sidewall should be monitored for further swelling.
